Cover Page

Program ID No. (primary): SWR 80951 Report date: August 2015
TCEQ Region No.: 4 MSD Certificate No.: _____
Additional Program ID Numbers.: SWR/Facility ID No.: _____ PST Facility ID No.: _____
DCRP ID No.: _____ VCP ID No.: _____ LPST ID No.: _____
MSW Tracking No.: _____ HW Permit/CP No.: _____ Enforcement ID No.: _____
Other ID Nos.: EPA CERCLIS TXD980865109

On-Site Property (Facility) Name: Former F.J. Doyle Transformer Salvage/Recycling Facility
Street no. 905 Pre dir: N. Street name: Poplar Street type: St Post dir: _____
City: Leonard County: Fannin County Code _____ Zip 75452
Nearest street intersection and location description: 0.344 acres, SW Corner of N. Poplar St and E. Cottonwood St

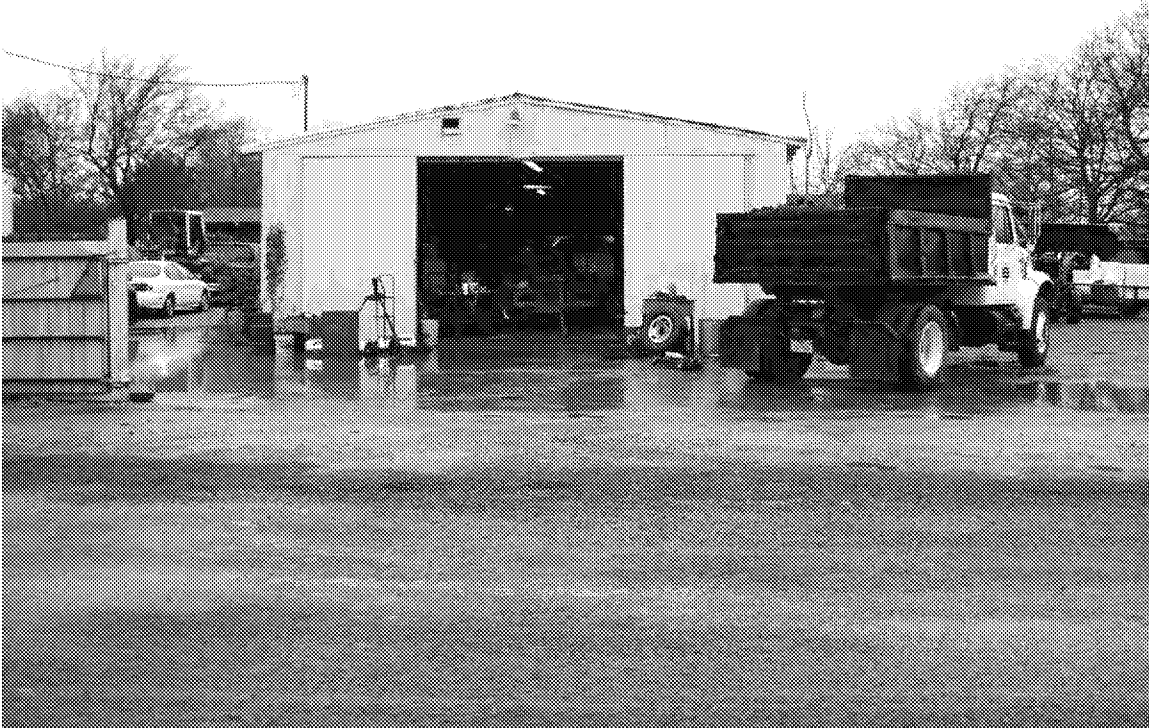
Photograph 1: View looking west of the automobile repair shop building. This building was previously used as the transformer recycling facility.

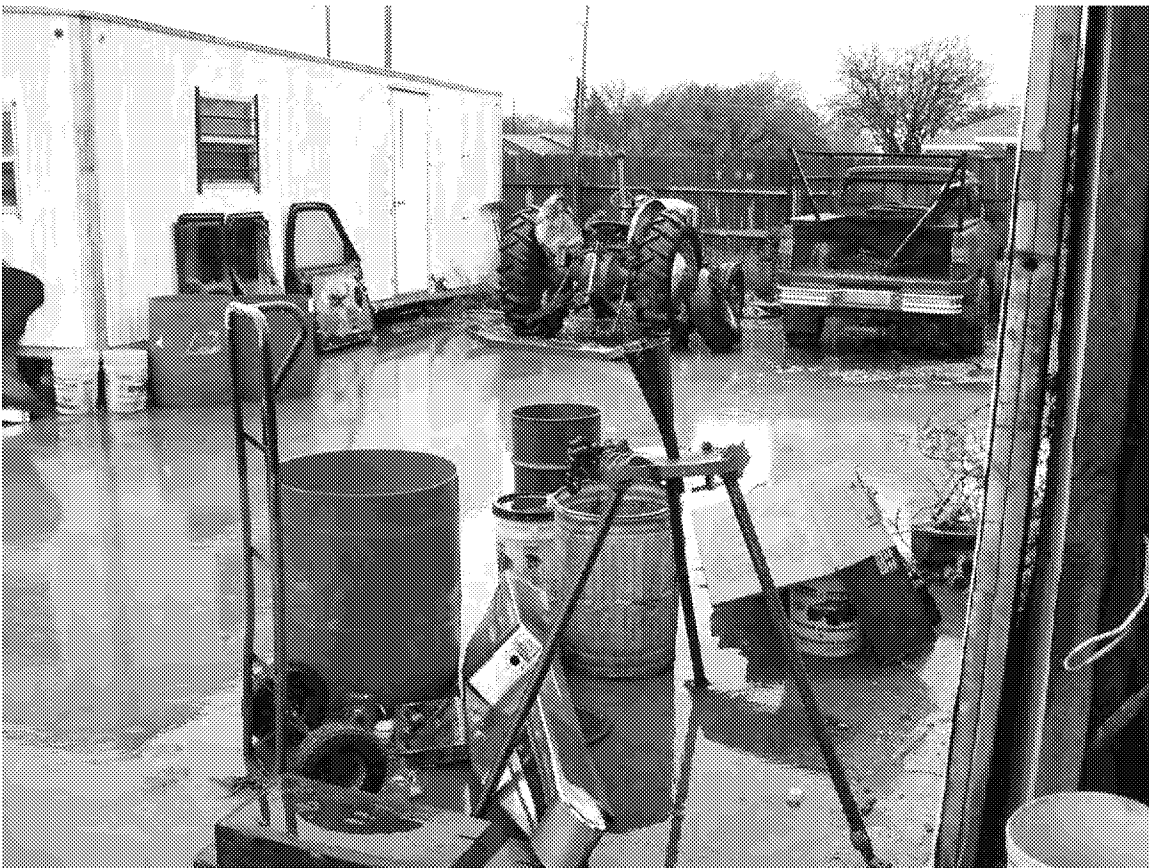
Photograph 3: View looking southeast of the portable building and of the exterior of the automobile repair shop.

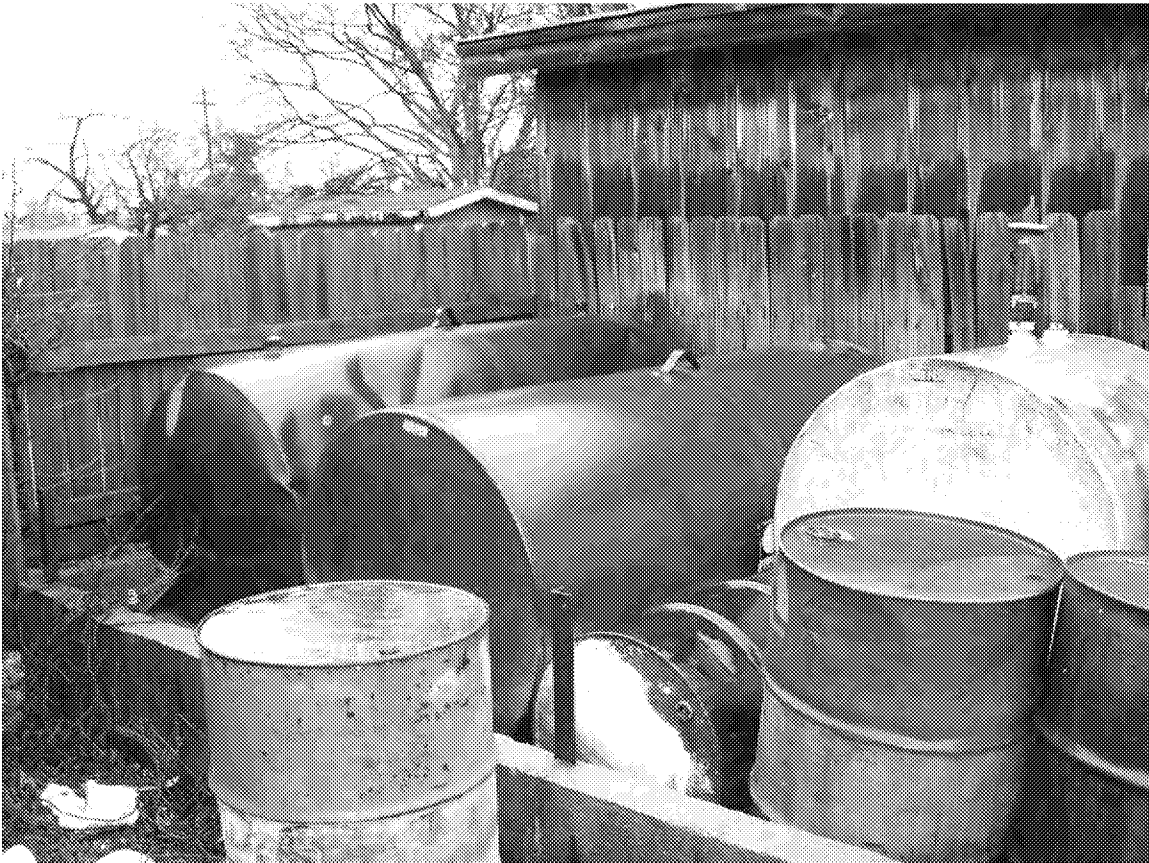
Photograph 4: View looking northwest the three aboveground storage tanks and multiple 55-gallon drums in and near the spill containment sump.

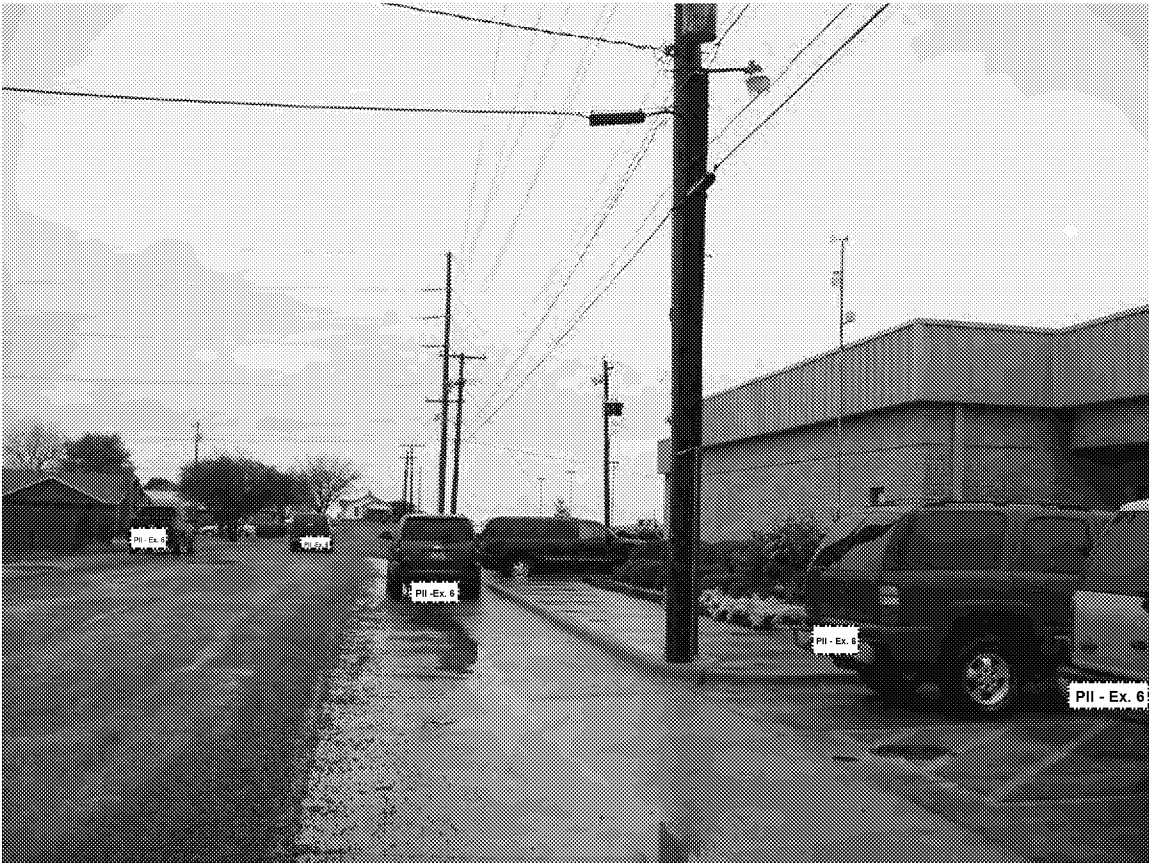
Photograph 6: View looking north along N. Poplar Street showing the school buildings east of the site. Also note the one transformed on the power pole in the foreground (#N6497) and in the three in the background (Nos. N23508, N21884, and N21888).

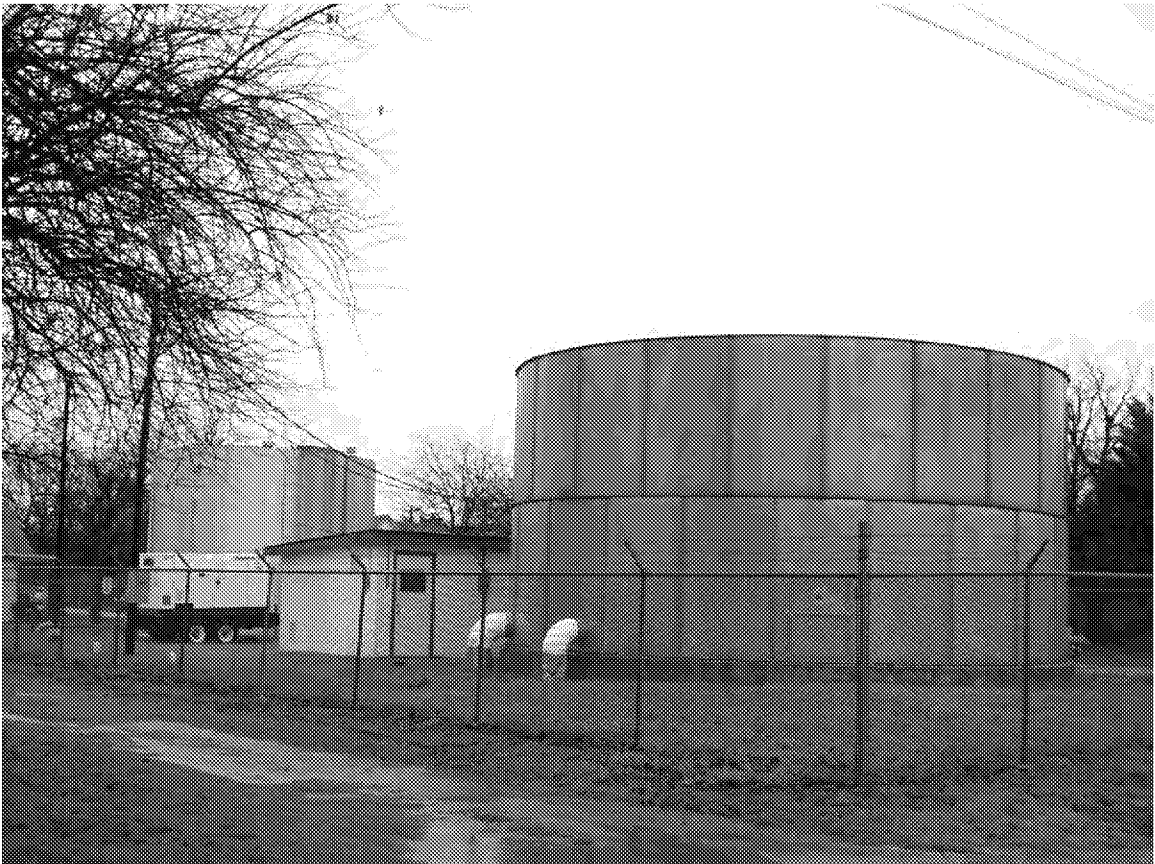
Photograph 8: View looking southeast of City Water Well #1 and its storage tanks located approximately 370 feet from the site

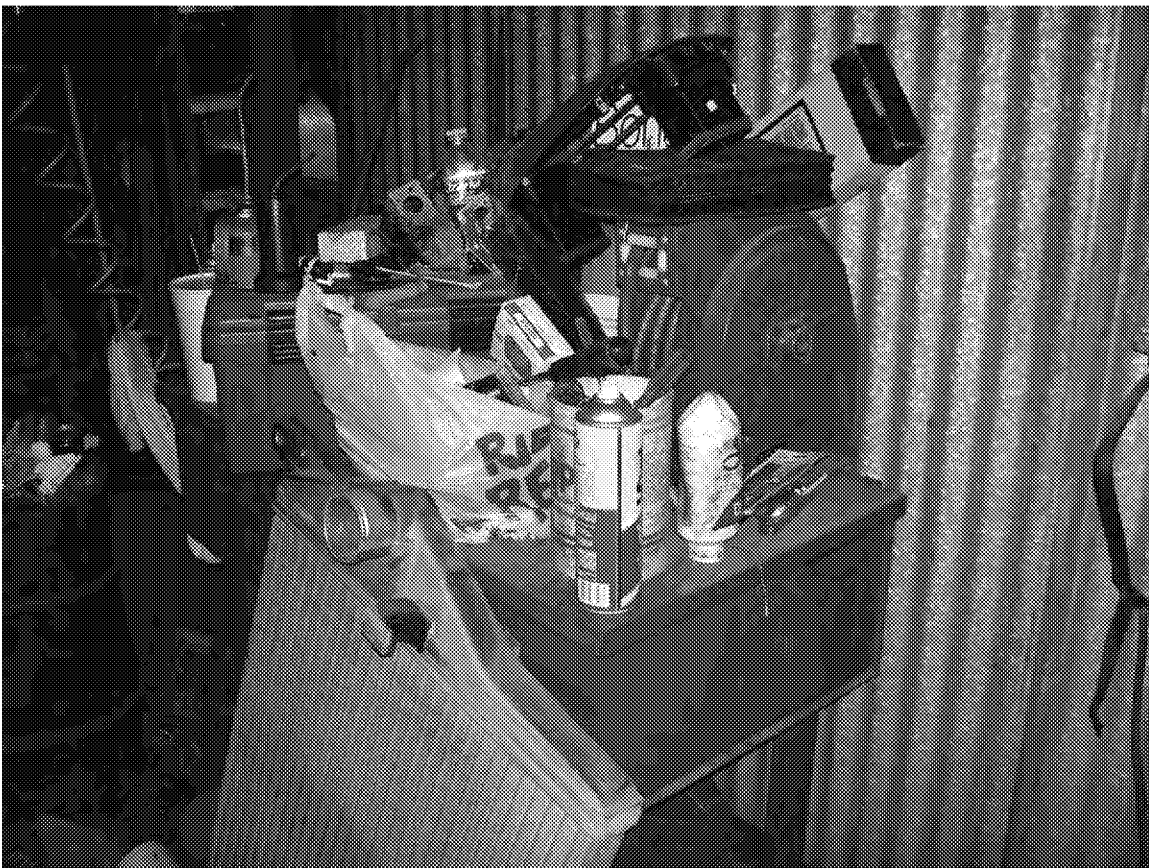
- Terra-Solve observed a solvent parts washer in the warehouse repair area. The warehouse and office storeroom also store various amounts of general cleaning and general maintenance supplies.

Photograph 9: View inside the shop building showing the parts washer and other chemicals.

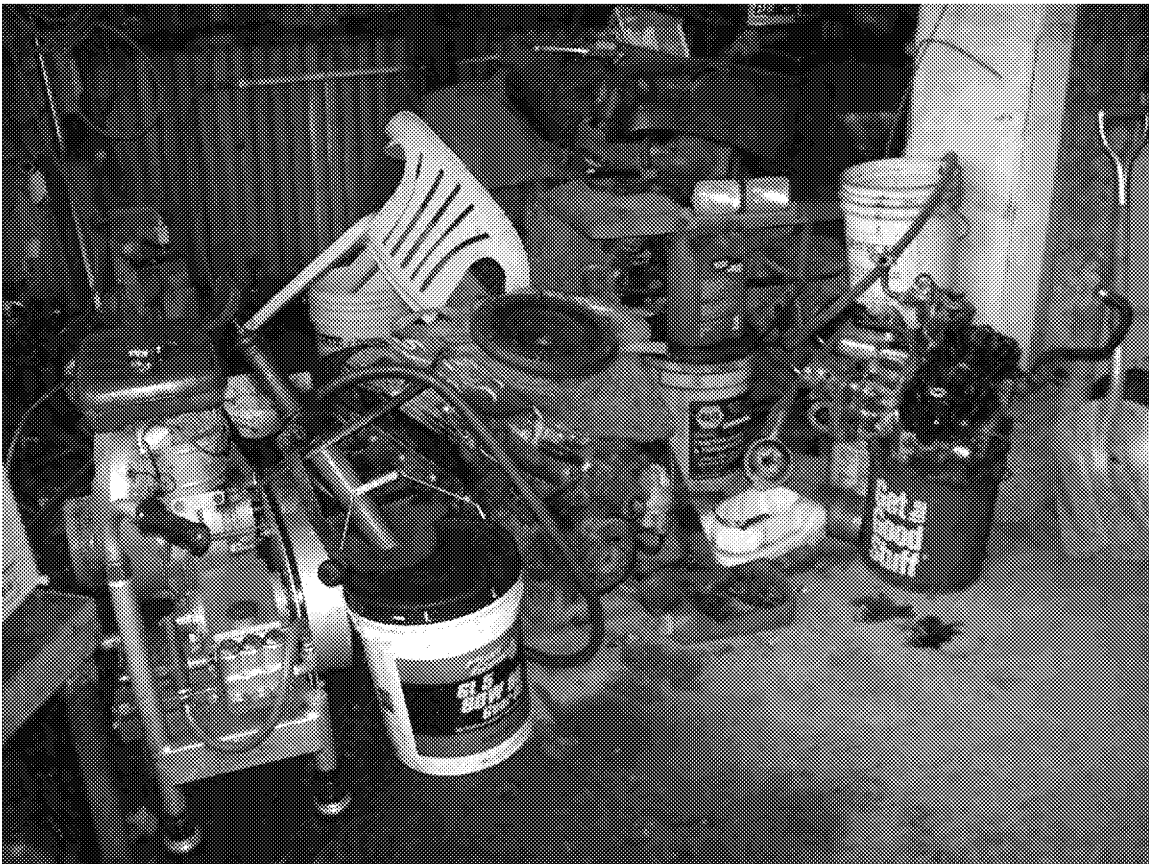
- Numerous areas of oil staining were observed on the concrete inside the shop building and staining was observed near the secondary containment basin and hydrocarbon sheens were observed in the parking lot.

Photograph 10: View inside the shop building showing 5-gallon buckets of chemicals and oil, both new and used. Numerous areas of stained concrete are visible in the shop.

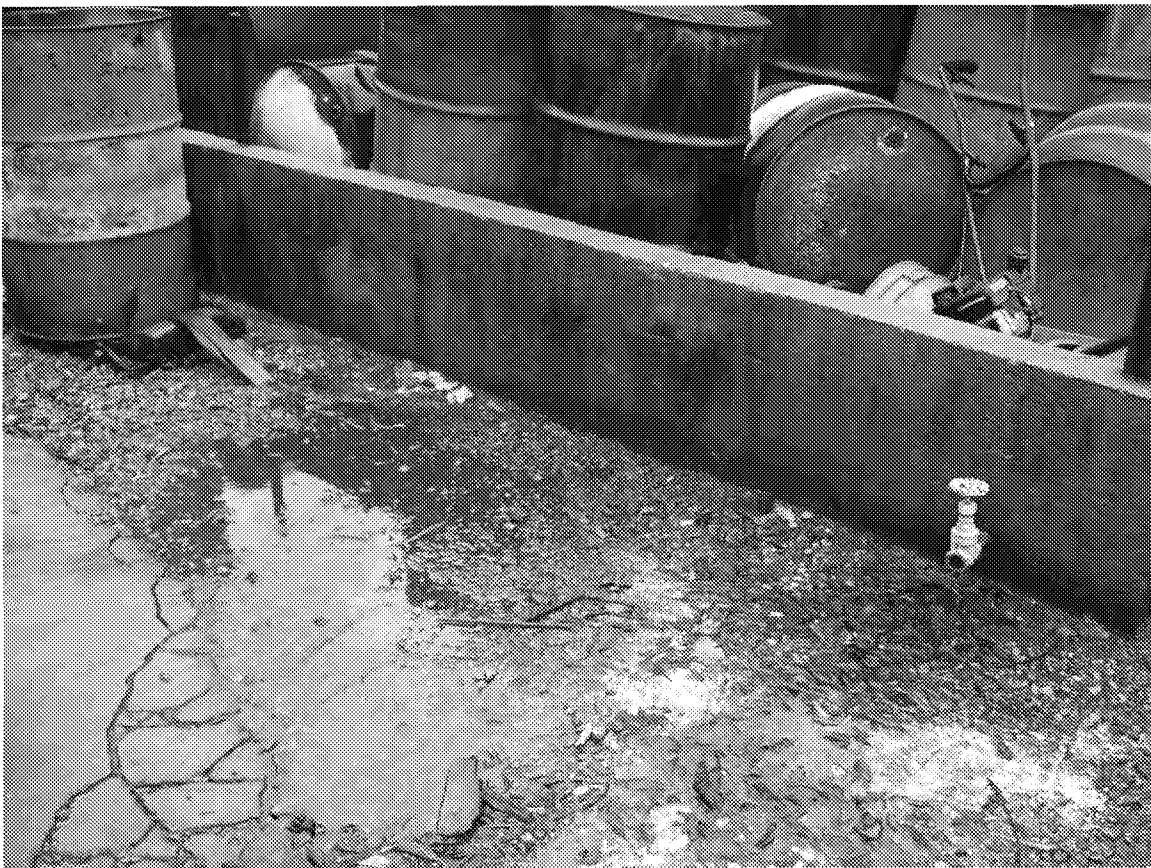
- A kerosene-dispensing AST was observed on the north side of the shop building. The AST appeared to be empty, but this could not be confirmed.
- Numerous 55-gallon drums of new/used oil and hydraulic fluid are located in and around the shop and numerous used and emptied drums are stored in and around the secondary containment basin.

Photograph 11: View looking southwest of the drums inside and outside the AST secondary containment basin. Note the drain valve and the stains and hydrocarbon sheen on the standing water.

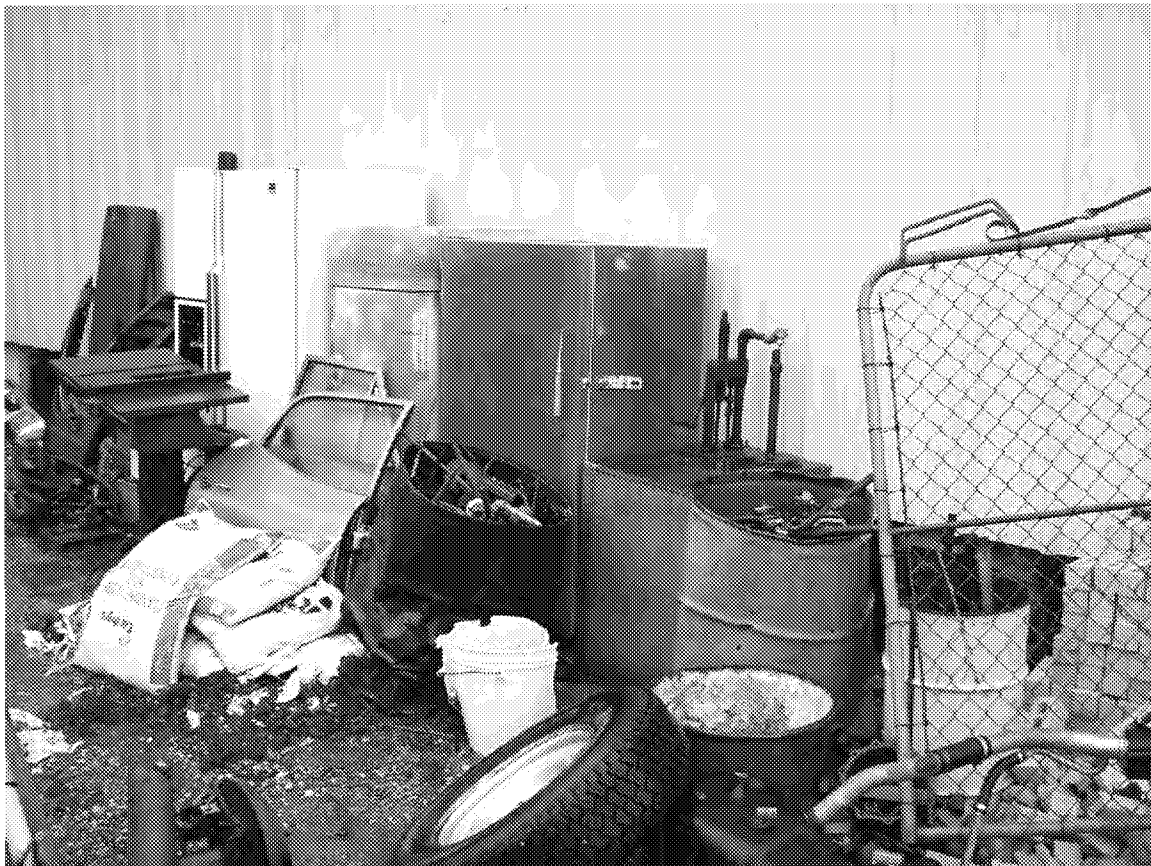
Photograph 12: View looking southeast the kerosene-dispensing AST, drums, and other debris on the north side of the shop building.

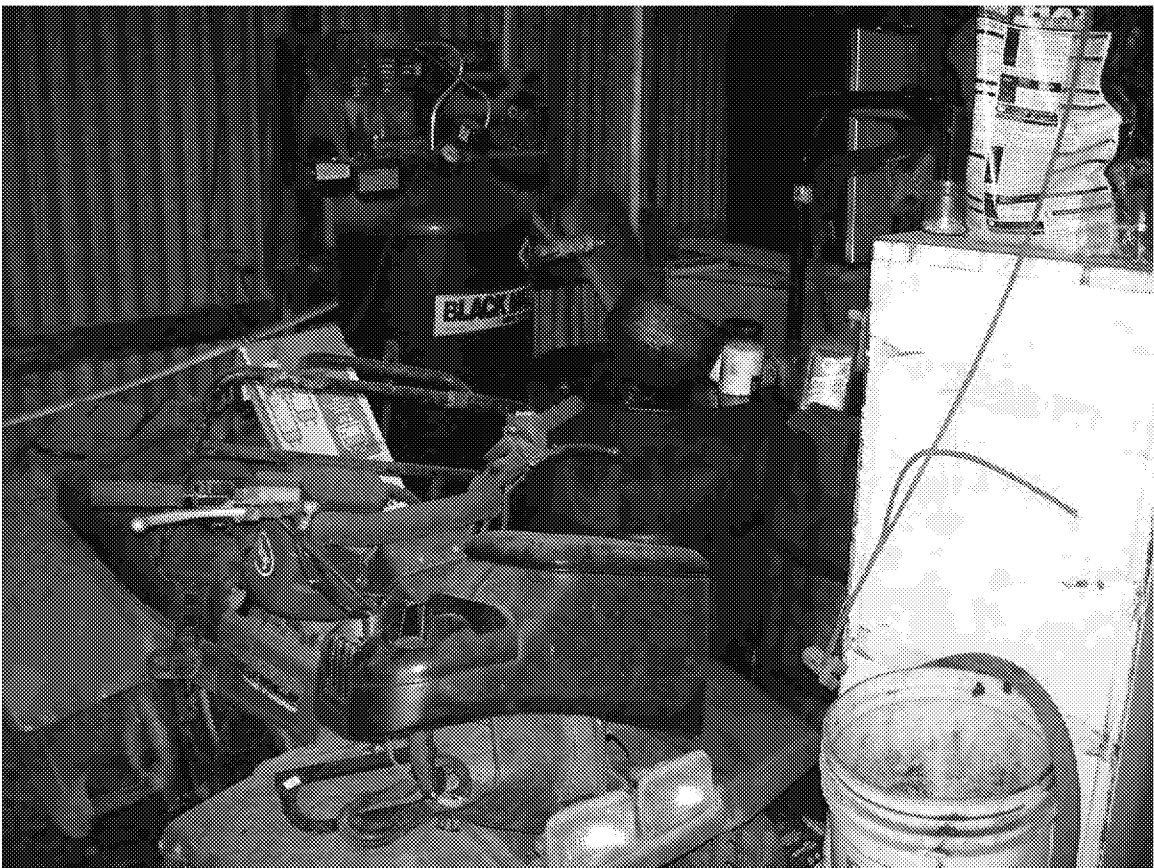
Photograph 13: View inside the shop building of equipment, parts, and new and used oil containers and drums.

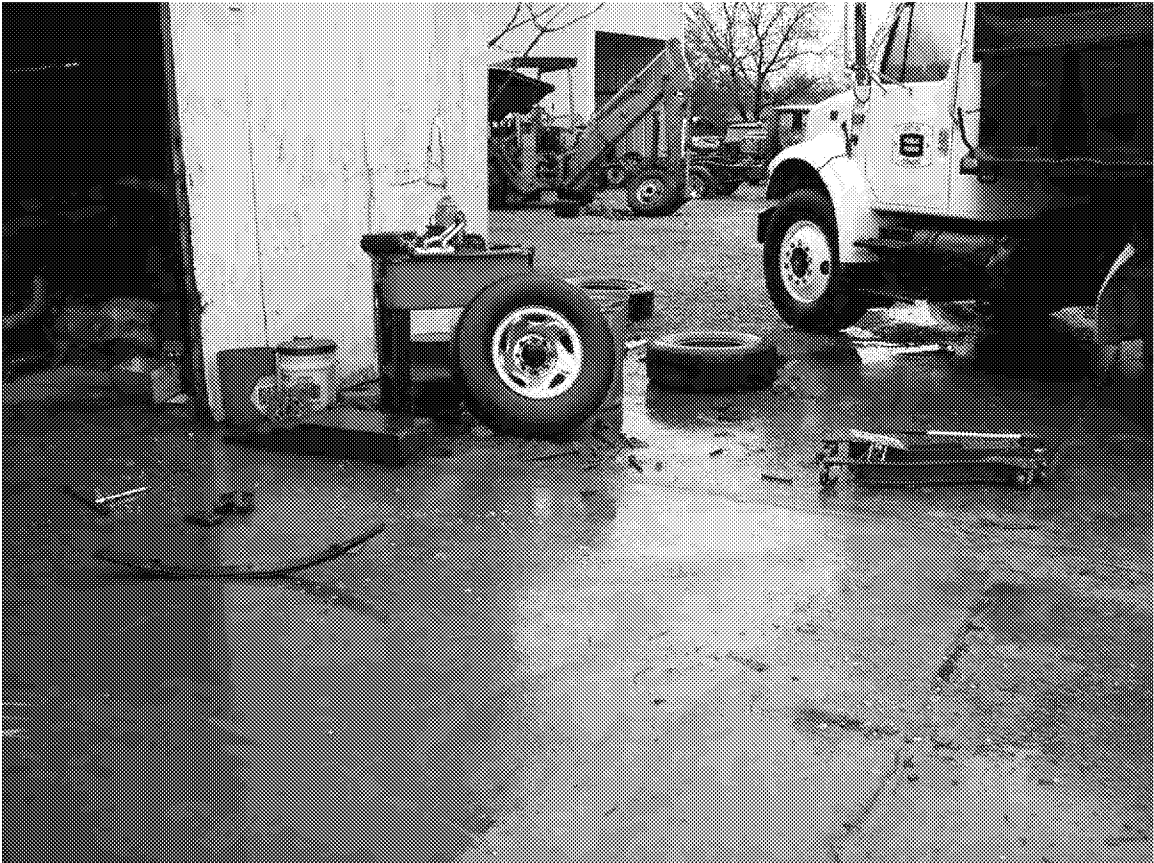
Photograph 14: View looking northwest of the rainbow hydrocarbon sheen visible on the concrete driveway near the shop building.

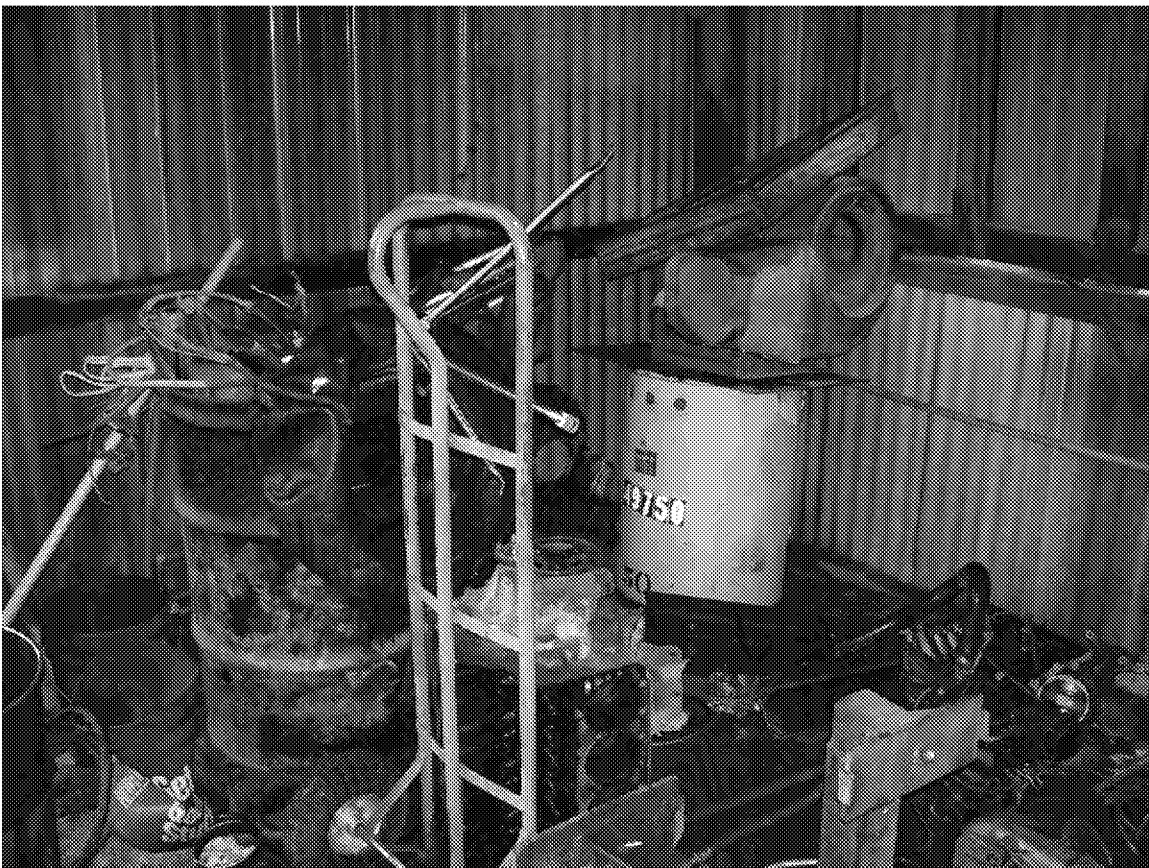
Photograph 15: View inside the shop building showing the leftover transformer from the salvage business. Note the blue "No PCB" sticker on the transformer. This area is where the furnace used for burning the insulation from the transformer was located.

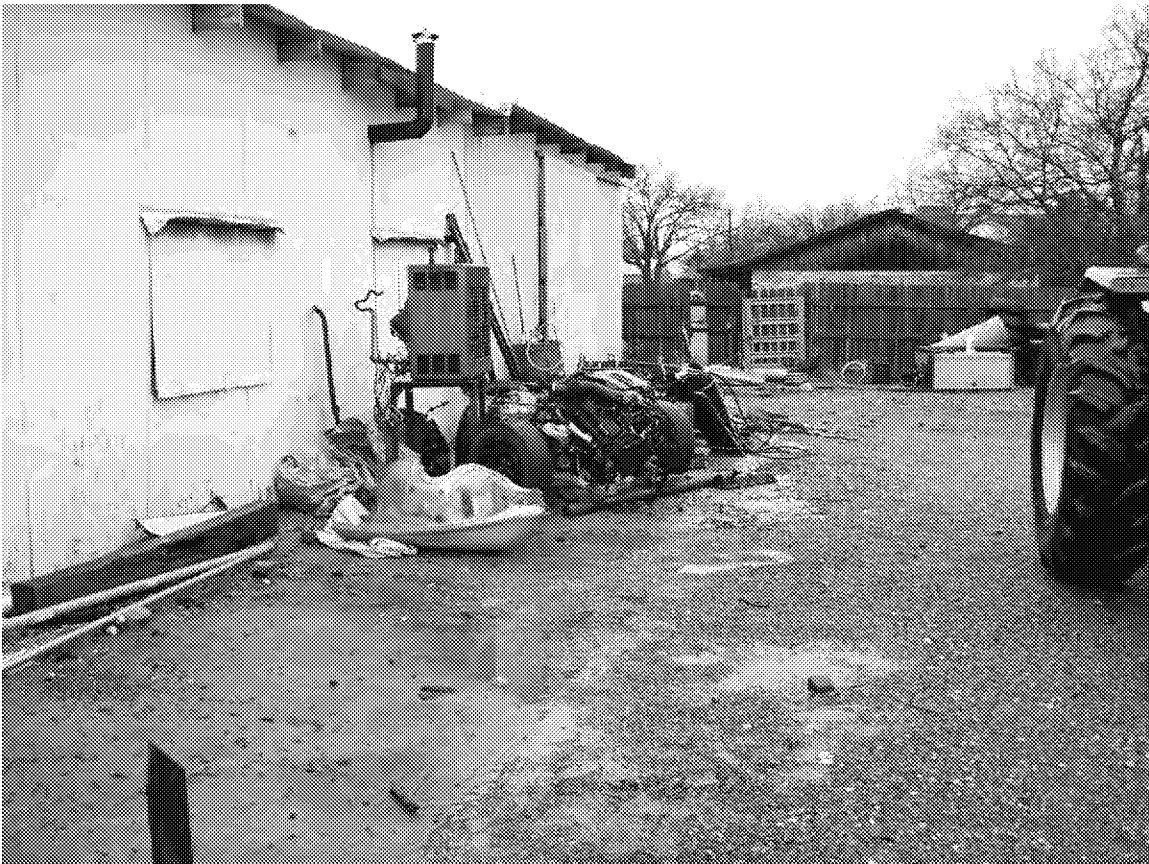
- Terra-Solve observed numerous unidentified containers on the property, mostly inside and near the shop building and on-site trash cans for authorized disposal. However, a large amount of debris and parts are stored on site.

Photograph 16: View looking southwest of the north side of the shop building showing some of the scattered areas of debris and parts.

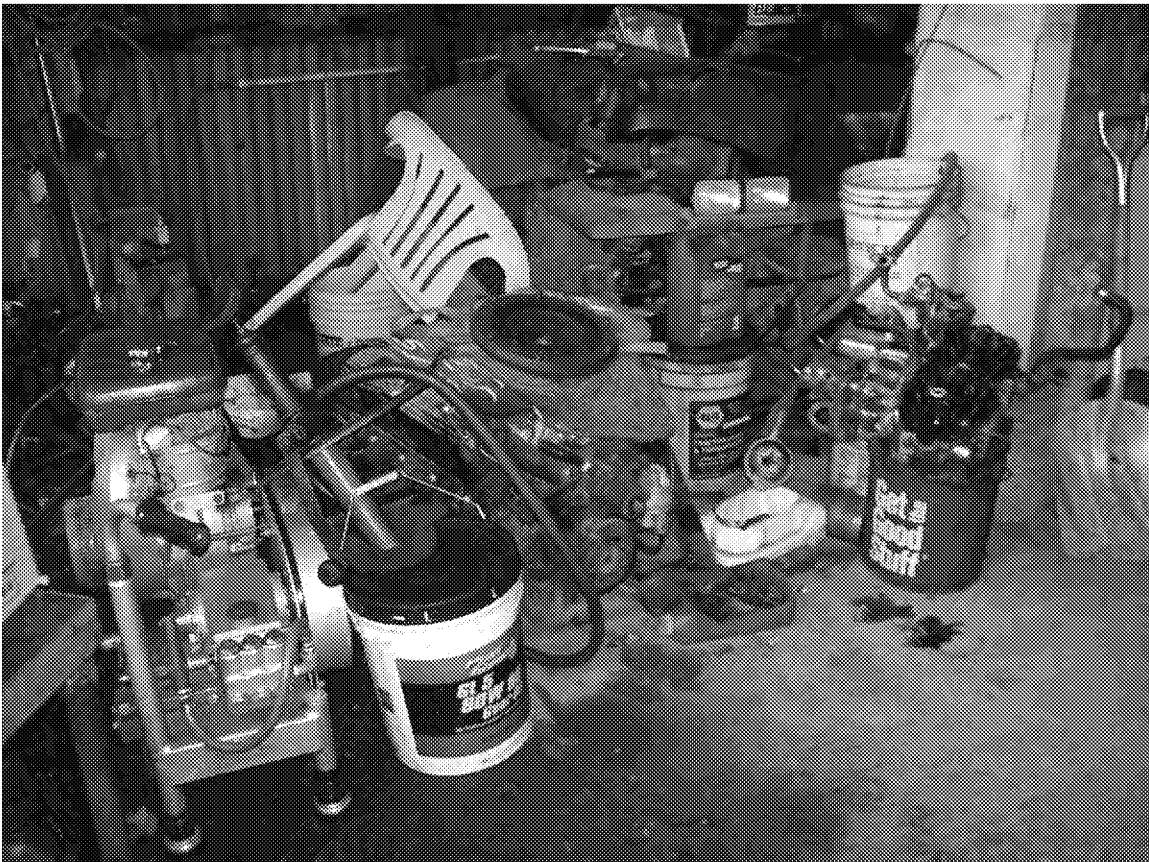
Photograph 10: View inside the shop building showing 5-gallon buckets of chemicals and oil, both new and used. Numerous areas of stained concrete are visible in the shop.

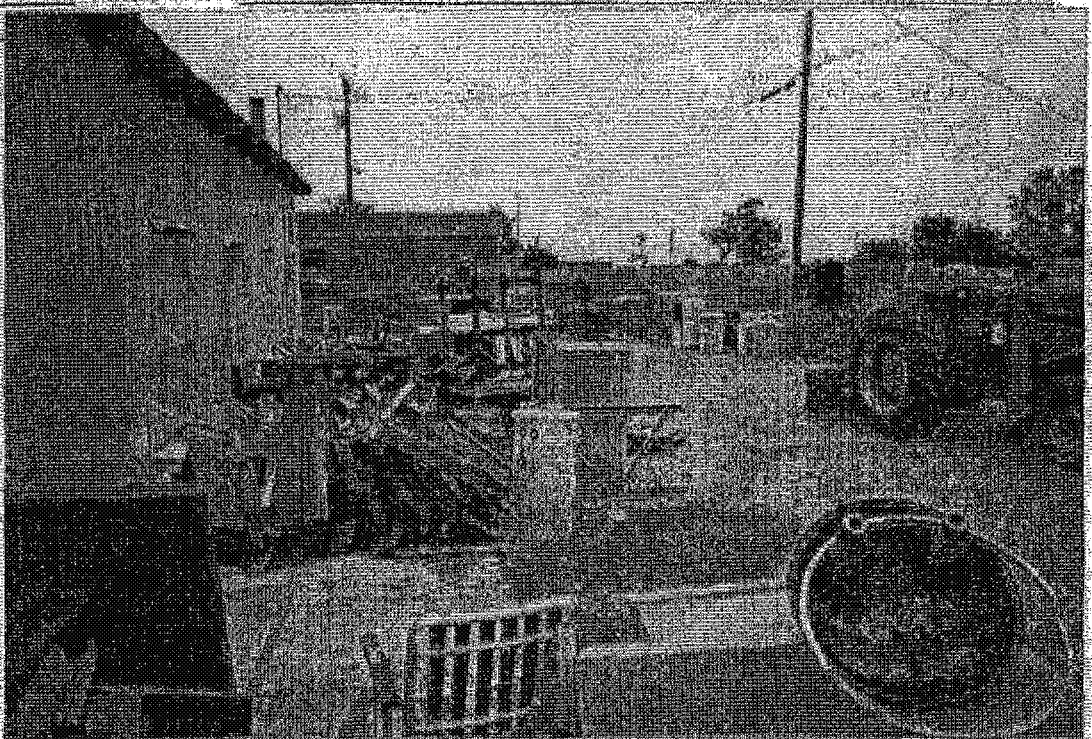
Photo No.
9
Neg. No.
7

Date: 5/20/97 Time: 10:30 Direction: East
 Description: The south side of the shop. Soil staining was located near the debris pile.

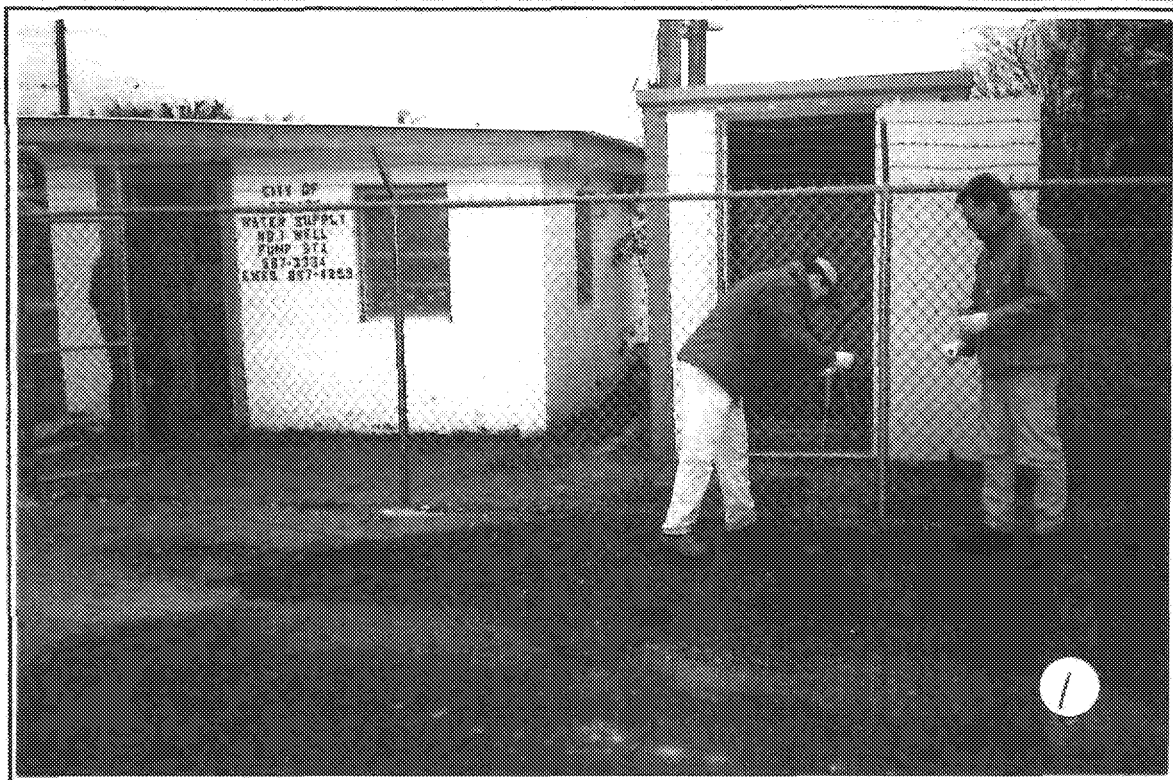
Photo #1 - (8:50 am) Well water sample GW-01 and a duplicate GW-02 were collected from the City of Leonard Water Supply Well No. 1 as shown above. Photo taken facing west.

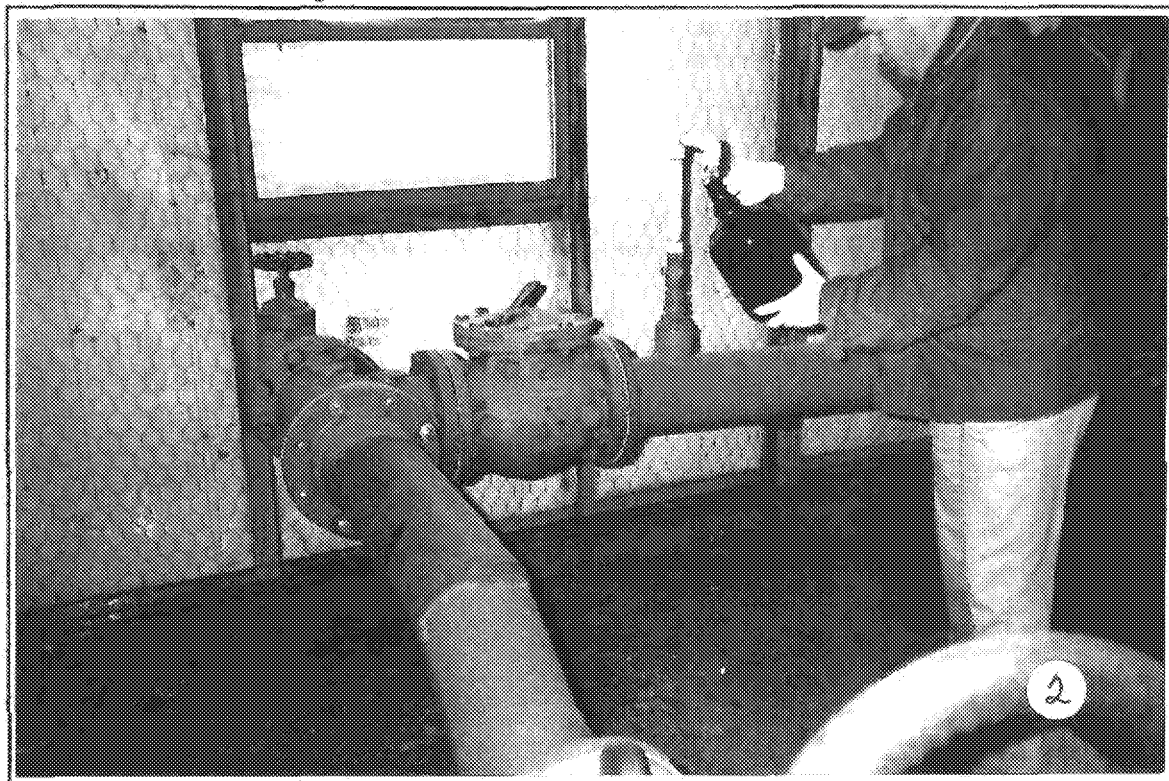
Photo #2 - (9:30 am) Well water sample GW-03 was collected from the City of Leonard Water Supply Well No. 2 as shown above. Photo taken inside pump house facing south.

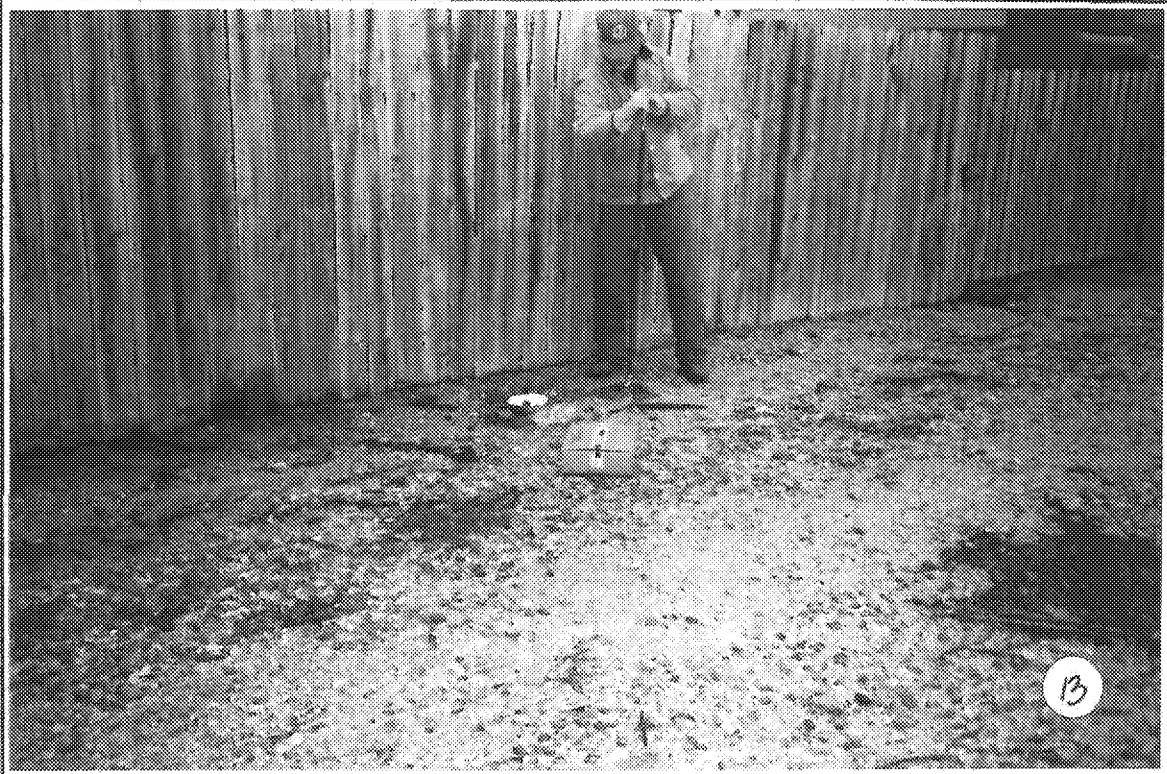
Photo #13 - (9:05 am) A soil sample SO-13 was collected along the south fenceline west of the south gate at a depth 6"-12" deep as shown above. Photo taken facing northeast.

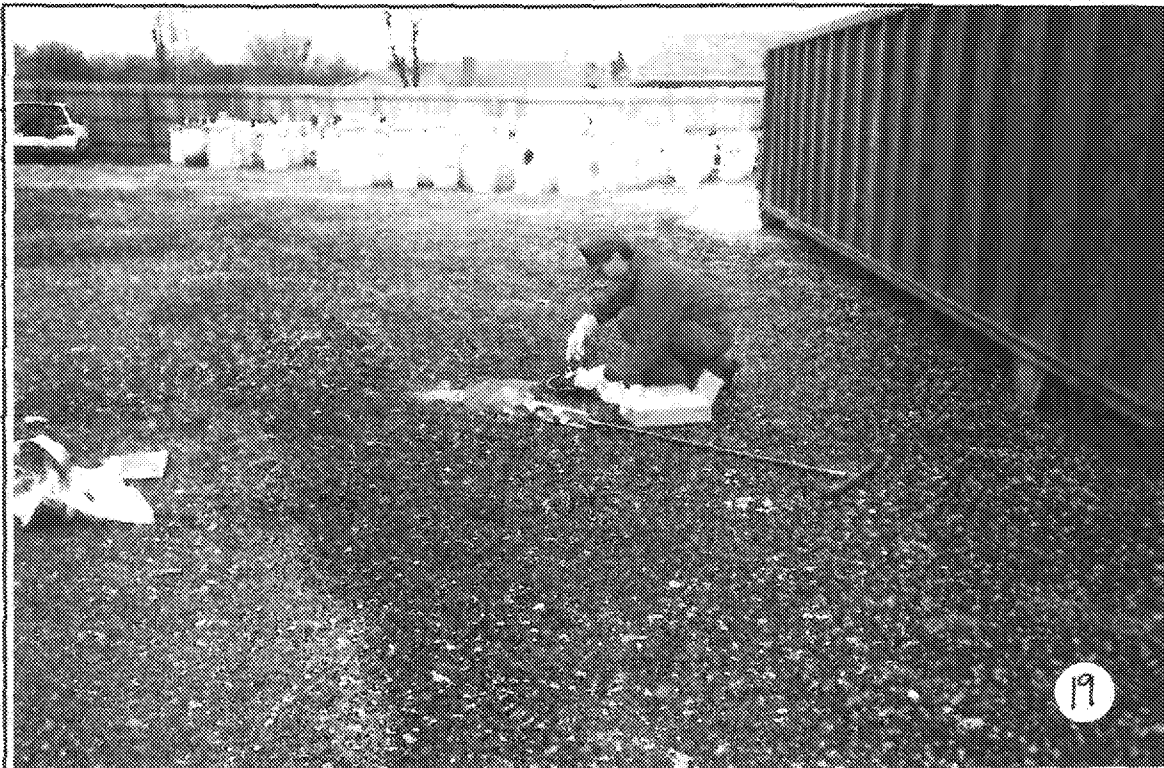
Photo #19 - (11:30 am) A soil sample SO-17 was collected from the transformer off-load area located in the north central portion of the site at a depth 6"-12" deep as shown above. Photo taken facing north.

A total of three (3) source characterization soil samples (SO-17, SO-18 and SO-19) were collected during the SSI at depths 6"-12" just below a compacted gravel base from the three identified on-site waste management areas to: (1) substantiate prior sample results, (2) determine current levels of remaining source contamination, and (3) obtain Contract Laboratory Program (CLP) quality data. A summary of sample location/rationale is provided in Table 5 and approximate sample locations are shown in Figure 5. Sample location photographs include Photos #19 thru #22 (see Appendix A). Sample documentation was recorded in a field log book (see Appendix B).

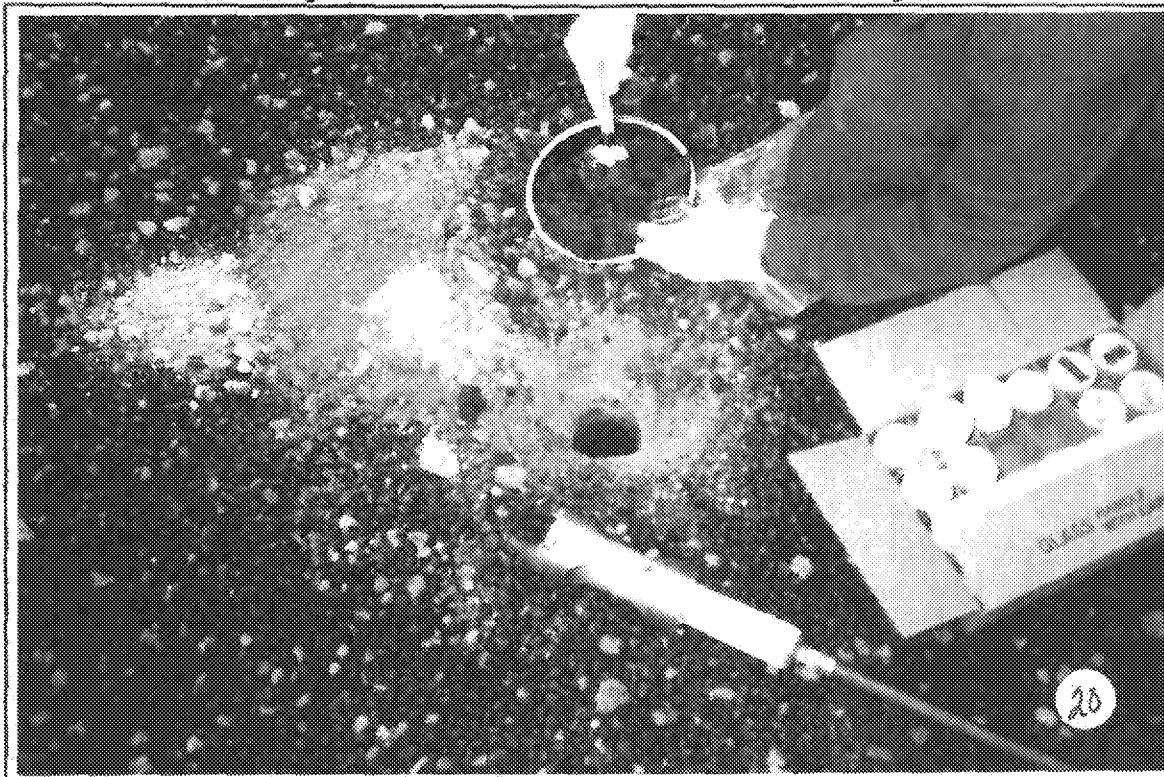
Photo #20 - (11:32 am) A close-up view of sample location SO-17 shows the dark stained soils below the rock and sand road base material in the off-load area.

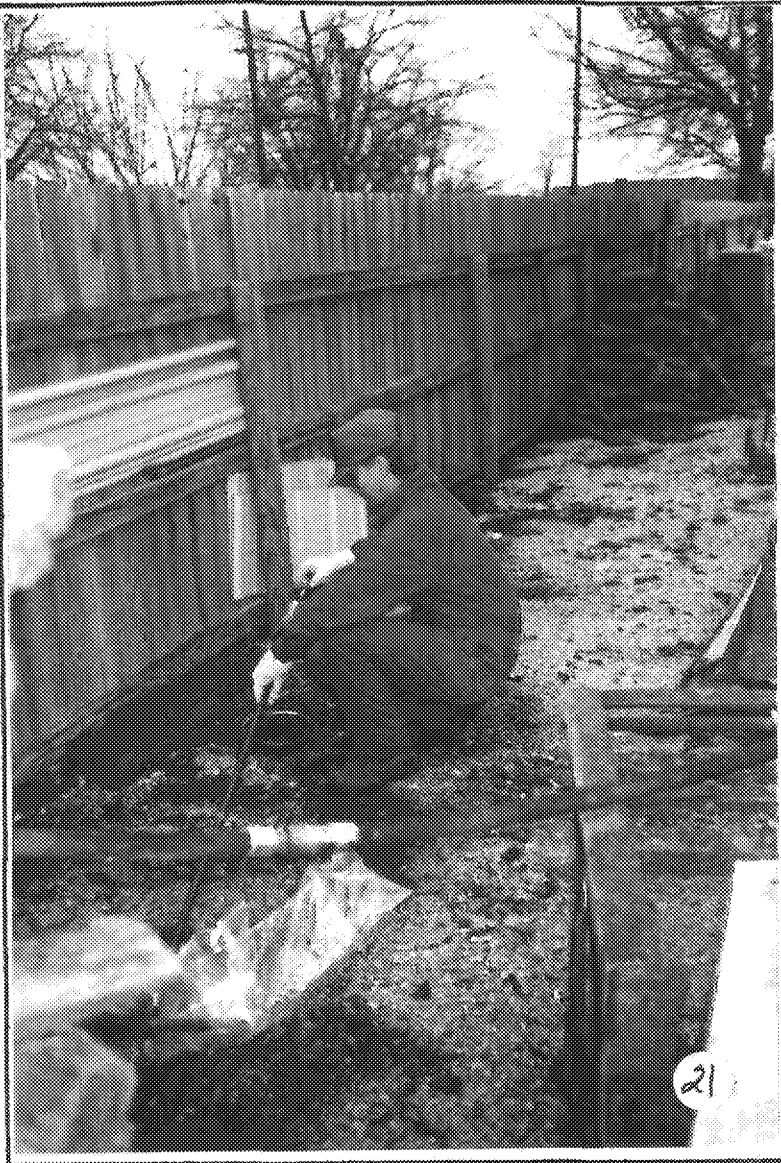
Photo #21 - (11:45 am) A soil sample SO-18 was collected along the west fenceline adjacent to the container storage area in the southwest portion of the site at a depth 6"-12" deep as shown at the left. Photo taken facing north.

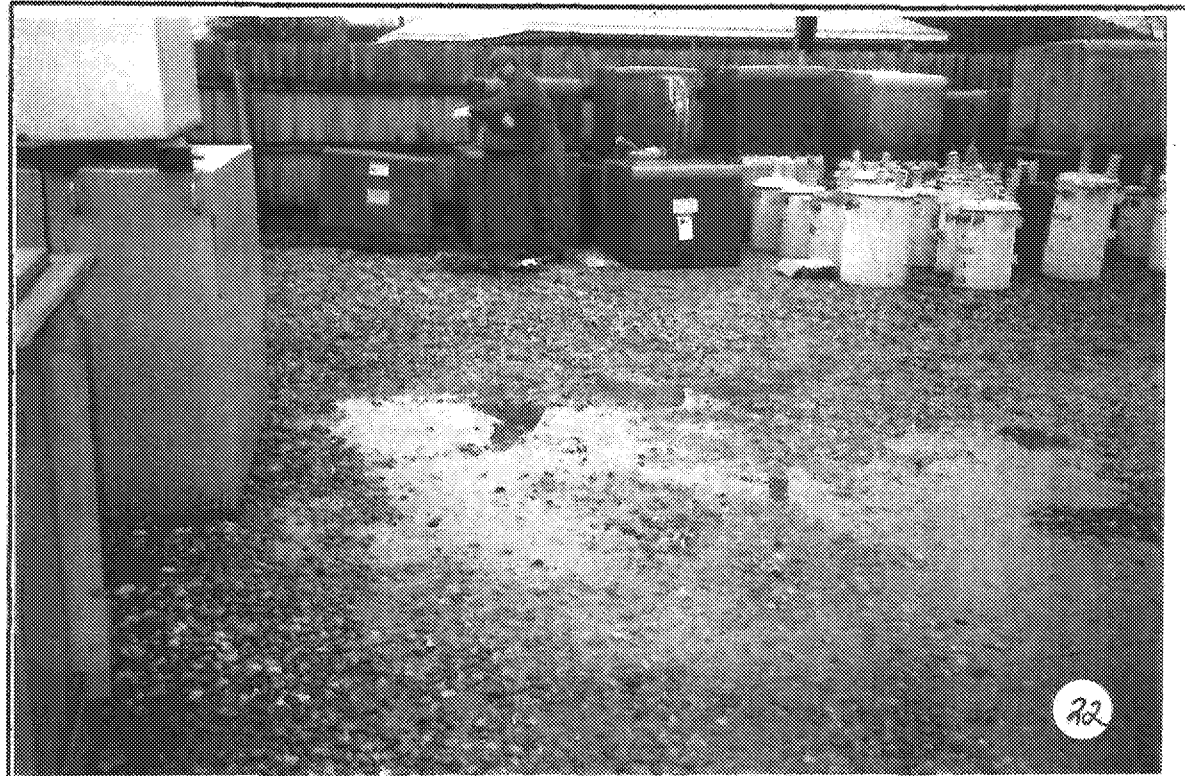
Photo #22 - (12:00 pm) A soil sample SO-19 was collected along the fence-line adjacent to the transformer storage area in the southeast portion of the site at a depth 6"-12" deep as shown below. Photo taken facing south.
